Mainlube Superior Maintenance Lubricants Pty Ltd

DATE 15/07/01

Oil Analysis No 1742 6 Speed Gearbox

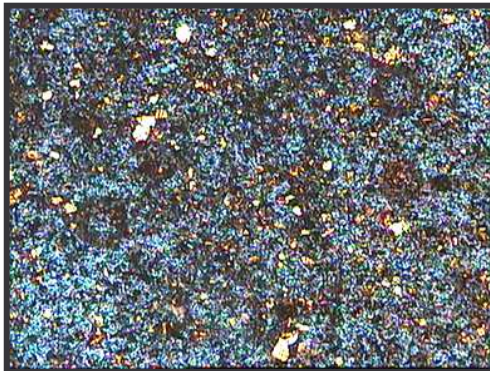
This image represents a 1-mm diameter circle focused on the top layer of the filter @ 100X. The green/blue coloured background is the microscopes bottom light shining up through the glass slide illustrating density level of dirt, metal chunks and debris particles.

This image demonstrates the average debris level for sample No. 0000
*To achieve an acceptable life from this application,
this image should be clear, no particles*

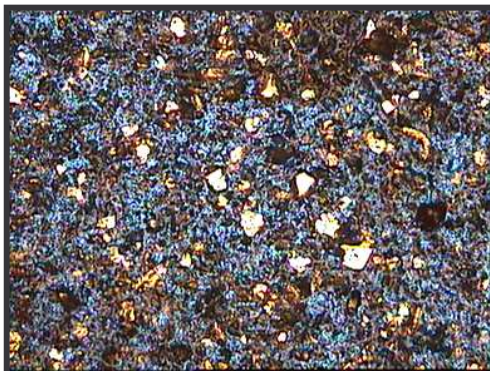
**Overview density of dirt,
Wear Metal Chunks and debris particles @ 200X.**

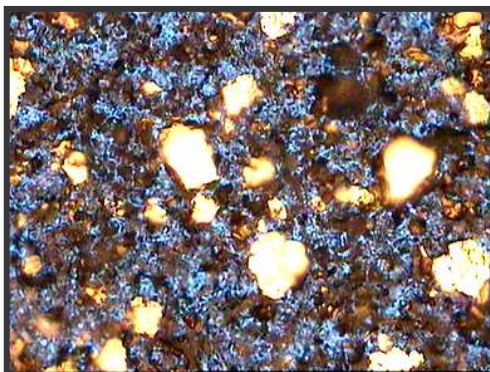
Scuffing Wear Particles "Damaged Surface"

5-25 Microns

"Damaged Surface" Scuffing Wear Particles began when a primary wear mode was generated and not addressed.

The damaged, torn and protruding bearing surfaces, easily penetrate the lubricant film, allowing metal to metal contact, tearing off more metal. This creates excessive wear and eventual machine failure, if not addressed in time.

These spalling metal particles are carried by the oil flow through other load zones, snowballing the effect and further damaging load-bearing surfaces.

Damage will continue to this machine until the contamination is completely removed

This contamination is causing damage to the machine and should be removed at the first opportunity.

If no terminal damage is found then proceed with flushing.

Mainlube recommends that the gearbox flushed with Mainlube 245 Flush to assist with the debris removal. If after flushing there is a possibility that wear debris still remains, then repeat the process until they are both clean.

Replace the lubricant with Mainlube 151 E P Gear Oil SAE 75w90, run for 10 hours and take sample for benchmark. Retest every 500 hours until trends are established.
