Mainlube Superior Maintenance Lubricants Pty Ltd

DATE 20/07/06

Wear Metal Analysis No 6041 ACT – Cross8

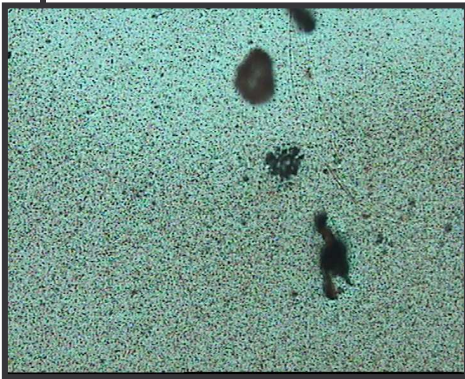
One mil. of the sample oil has been forced through a 13-mm diameter **0.3-micron membrane filter @ 150 P.S.I.** The membrane filter has caught any contaminates present, filters are glass slide mounted for examination. This image represents a 1-mm diameter circle focused on the top layer of the filter **@ 100X**. The green/blue coloured background is the microscopes bottom light shining up through the glass slide illustrating density level of dirt, metal chunks and debris particles.

This image demonstrates the average debris level for sample No. 6041
*To achieve an acceptable life from this application,
 this image should be clear, no particles*

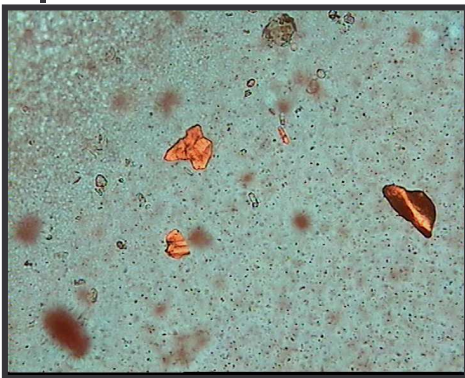
**Overview density of dirt,
 Wear Metal Chunks and debris particles @ 200X.**

This sample is contaminated with 3 Body Fatigue Wear and Laminar Wear Metal particles.

Although this report shows many wear modes present, the amount of each mode is quite low indicating extensive damage has not yet happened. You can see this by the lack of metal in the background.

Mainlube recommends that the gearbox flushed with Mainlube 245 Flush to assist with the debris removal. If after flushing there is a possibility that wear debris still remains, then repeat the process until they are both clean.

Replace the lubricant with Mainlube 175 Synthetic Race Oil, run for 10 minutes and take sample for benchmark.

Retest every 5000 klms until trends are established.

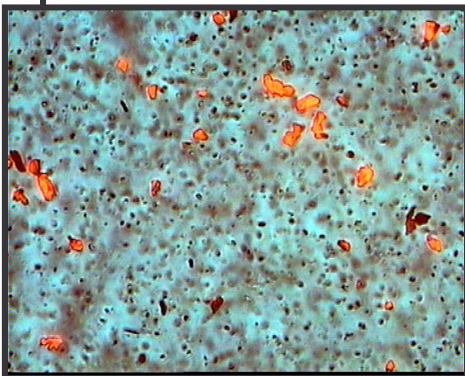
**Overview density of dirt,
 Wear Metal Chunks and debris particles @ 500X.**

together these wear modes are being forced through the load zone by the lubricant flow causing further damage by generating 3 Body Fatigue wear and finally rolled out flat to form Laminar Wear Metal particles. Friction Polymers are formed when the lubricant is heavily stressed.

This contamination is causing damage to the machine and should be removed at the first opportunity.
