DATE 10/08/06

### Wear Metal Analysis No 6047 Drew T56

**Method.** Sample of approx 100 ml received from **T56 Gearbox @ 30,000 klms, running on ATF.** Sample preparation in accordance with Mainlube standard laboratory practices. One sample processed 1 ml in volume; therefore the amount seen in the video pictures is the actual debris concentration per ml of oil.

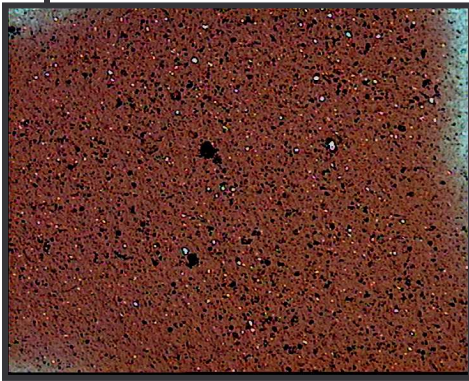
**One mil.** of the sample oil has been forced through a 13-mm diameter **0.3-micron membrane filter @ 150 P.S.I.** The membrane filter has caught any contaminates present, filters are glass slide mounted for examination. This image represents a 1-mm diameter circle focused on the top layer of the filter **@ 100X**. The green/blue coloured background is the microscopes bottom light shinning up through the glass slide illustrating density level of dirt, metal chunks and debris particles.

**This image demonstrates the average debris level for sample No. 6047**  
*To achieve an acceptable life from this application,  
this image should be clear, no particles*

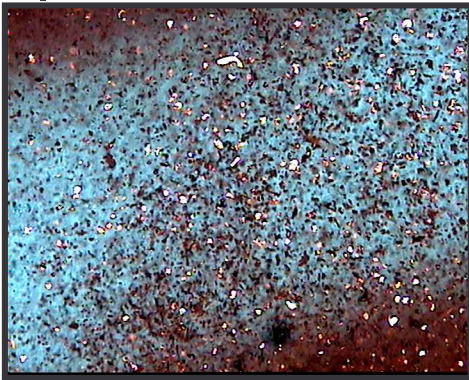
**Overview density of dirt,  
Wear Metal Chunks and debris particles @ 200X.**

This sample is contaminated with 2 Body Fatigue Wear, Scuffing, Scuffing Wear – “Damaged Surface”, 3 Body Fatigue Wear.

Scuffing Wear – “Damaged Surface” Particles began when a primary wear mode was generated and not addressed, 2 Body Fatigue chunks occur when the machines cyclic application of the stress, is in excess of the design value, Dark Metallo-Oxide and Black Oxide Particles are formed when machine is being over driven beyond the capability of the lubricant, together these wear modes are being forced through the load zone by the lubricant flow causing further damage by generating 3 Body Fatigue wear and finally rolled out flat to form Laminar Wear Metal particles. Friction Polymers are formed when the lubricant is heavily stressed.

Although this report shows many wear modes present, the amount of each mode is quite low indicating extensive damage has not yet happened. You can see this by the lack of metal in the background.

Mainlube recommends that the gearbox flushed with Mainlube 245 Flush to assist with the debris removal. If after flushing there is a possibility that wear debris still remains, then repeat the process until they are both clean. The source of any Silica contamination should be established and prevented from recurring with a Mainlube Bladder Vent and Water Drain System.

Replace the lubricant with Mainlube 154 Synthetic Solid Boundary E P Gear Oil SAE 75w90, run for 10 minutes and take sample for benchmark.

Retest every 5000 klms until trends are established.

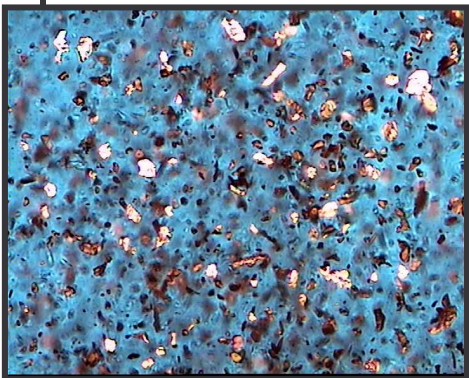
**Overview density of dirt,  
Wear Metal Chunks and debris particles @ 500X.**
