Mainlube Superior Maintenance Lubricants Pty Ltd

DATE 03/09/07

Wear Metal Analysis No 7087 Gentech Performance – T56

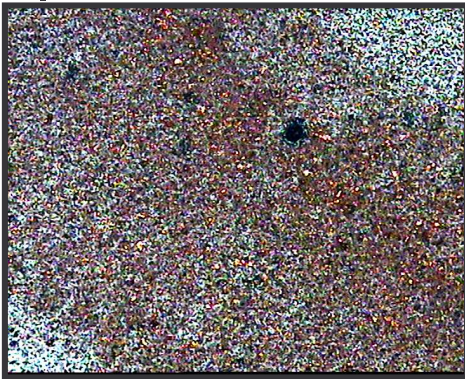
This image represents a 1-mm diameter circle focused on the top layer of the filter **@ 100X**. The green/blue coloured background is the microscopes bottom light shining up through the glass slide illustrating density level of dirt, metal chunks and debris particles.

This image demonstrates the average debris level for sample No. 7087

*To achieve an acceptable life from this application,
this image should be clear, no particles*

This sample is contaminated with Scuffing Wear damaged surface, 3 Body Fatigue Wear, Laminar Wear and Organic Debris.

Scuffing Wear – “Damaged Surface” Particles began when a primary wear mode was generated and not addressed, 3 Body Fatigue wear is being forced through the load zone by the lubricant flow causing further damage by generating more 3 Body Fatigue wear and finally rolled out flat to form Laminar Wear Metal particles. Friction Polymers are formed when the lubricant is heavily stressed.

This contamination is causing damage to the machine and should be removed at the first opportunity.

Mainlube recommends that the gearbox flushed with Mainlube 245 Flush to assist with the debris removal. If after flushing there is a possibility that wear debris still remains, then repeat the process until they are both clean.

Replace the lubricant with Mainlube 154 Synthetic Solid Boundary E P Gear Oil SAE 75w90, run for 10 minutes and re-sample for benchmark.

Retest every 12 months until trends are established.

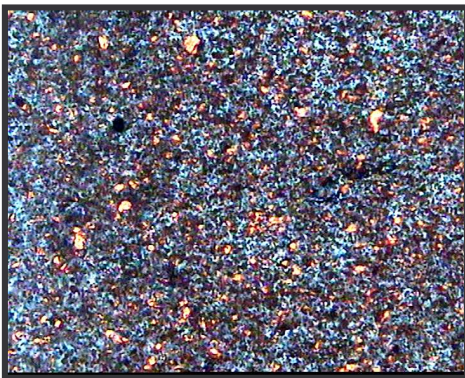
Overview density of dirt,

Wear Metal Chunks and debris particles **@ 200X.**

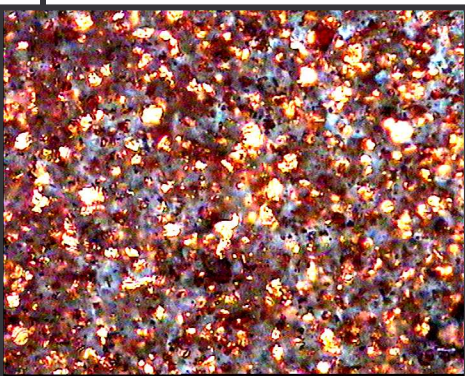
Overview density of dirt,

Wear Metal Chunks and debris particles **@ 500X.**
