Mainlube Superior Maintenance Lubricants Pty Ltd

Wear Metal Analysis No 6046 TigerSS - T56

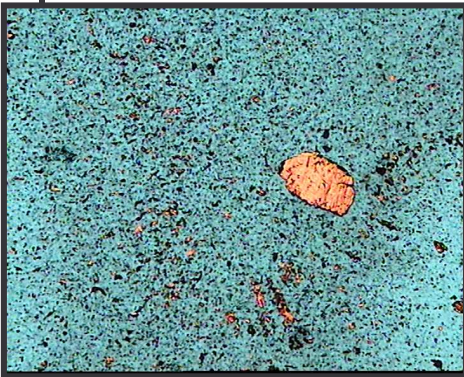
One mil. of the sample oil has been forced through a 13-mm diameter **0.3-micron membrane filter @ 150 P.S.I.** The membrane filter has caught any contaminates present, filters are glass slide mounted for examination. This image represents a 1-mm diameter circle focused on the top layer of the filter **@ 100X**. The green/blue coloured background is the microscopes bottom light shining up through the glass slide illustrating density level of dirt, metal chunks and debris particles.

This image demonstrates the average debris level for sample No. 6046
*To achieve an acceptable life from this application,
this image should be clear, no particles*

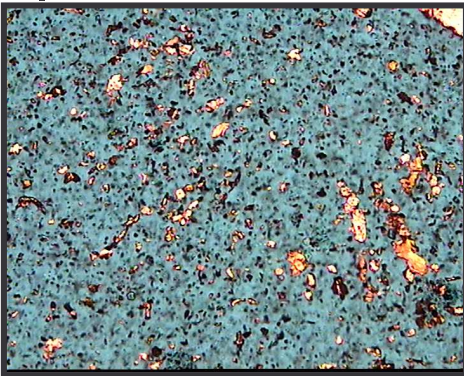
**Overview density of dirt,
Wear Metal Chunks and debris particles @ 200X.**

This sample is contaminated with 2 Body Fatigue Wear, Scuffing, Scuffing Wear – “Damaged Surface”, 3 Body Fatigue Wear.

Mainlube recommends that the gearbox flushed with Mainlube 245 Flush to assist with the debris removal. If after flushing there is a possibility that wear debris still remains, then repeat the process until they are both clean. The source of any Silica contamination should be established and prevented from recurring with a Mainlube Bladder Vent and Water Drain System.

Replace the lubricant with Mainlube 154 Synthetic Solid Boundary E P Gear Oil SAE 75w90, run for 10 minutes and take sample for benchmark.

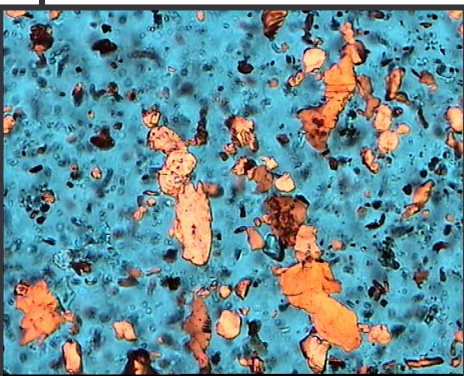
**Overview density of dirt,
Wear Metal Chunks and debris particles @ 500X.**

Scuffing Wear – “Damaged Surface” Particles began when a primary wear mode was generated and not addressed, 2 Body Fatigue chunks occur when the machines cyclic application of the stress, is in excess of the design value, together these wear modes are being forced through the load zone by the lubricant flow causing further damage by generating 3 Body Fatigue wear and finally rolled out flat to form Laminar Wear Metal particles. Friction Polymers are formed when the lubricant is heavily stressed.
