Wear Metal Analysis No 8049 Ronny T56

Method. Sample of approx 100 ml received from **T56 Gearbox @ 20,000 klms, running on Transmax Z.** Sample preparation in accordance with Mainlube standard laboratory practices. One sample processed 1 ml in volume; therefore the amount seen in the video pictures is the actual debris concentration per ml of oil.

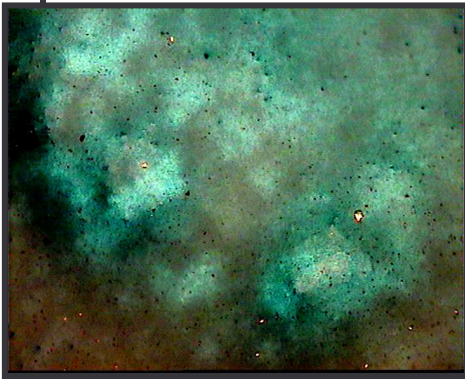
One mil. of the sample oil has been forced through a 13-mm diameter **0.3-micron membrane filter @ 150 P.S.I.** The membrane filter has caught any contaminates present, filters are glass slide mounted for examination. This image represents a 1-mm diameter circle focused on the top layer of the filter **@ 100X**. The green/blue coloured background is the microscopes bottom light shinning up through the glass slide illustrating density level of dirt, metal chunks and debris particles.

This image demonstrates the average debris level for sample No. 6049
*To achieve an acceptable life from this application,
this image should be clear, no particles*

This sample is contaminated with 2 Body Fatigue Wear, Scuffing, Scuffing Wear – “Damaged Surface”, 3 Body Fatigue Wear.

Scuffing Wear – “Damaged Surface” Particles began when a primary wear mode was generated and not addressed, 2 Body Fatigue chunks occur when the machines cyclic application of the stress, is in excess of the design value, together these wear modes are being forced through the load zone by the lubricant flow causing further damage by generating 3 Body Fatigue wear and finally rolled out flat to form Laminar Wear Metal particles. Friction Polymers are formed when the lubricant is heavily stressed.

Although this report shows many wear modes present, the amount of each mode is quite low indicating extensive damage has not yet happened. You can see this by the lack of metal in the background.

Mainlube recommends that the gearbox flushed with Mainlube 245 Flush to assist with the debris removal. If after flushing there is a possibility that wear debris still remains, then repeat the process until they are both clean. The source of any Silica contamination should be established and prevented from recurring with a Mainlube Bladder Vent and Water Drain System.

Replace the lubricant with Mainlube 154 Synthetic Solid Boundary E P Gear Oil SAE 75w90, run for 10 minutes and take sample for benchmark.

Retest every 5000 klms until trends are established.

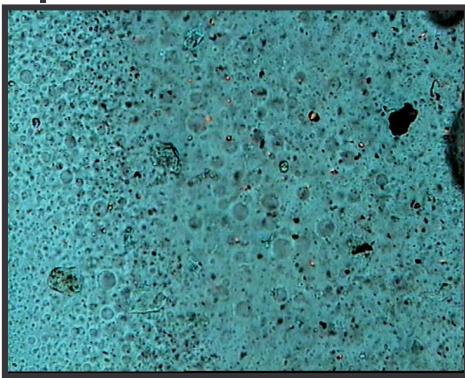
**Overview density of dirt,
Wear Metal Chunks and debris particles @ 200X.**

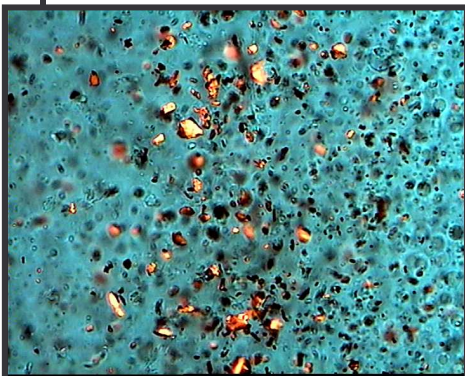
**Overview density of dirt,
Wear Metal Chunks and debris particles @ 500X.**
