Mainlube Superior Maintenance Lubricants Pty Ltd

Wear Metal Analysis No 6050 J D Biddle VYSS T56

Method. Sample of approx 100 ml received from **T56 Gearbox @ 70,000 klms, running on ATF Dexron III.** Sample preparation in accordance with Mainlube standard laboratory practices. One sample processed 1 ml in volume; therefore the amount seen in the video pictures is the actual debris concentration per ml of oil.

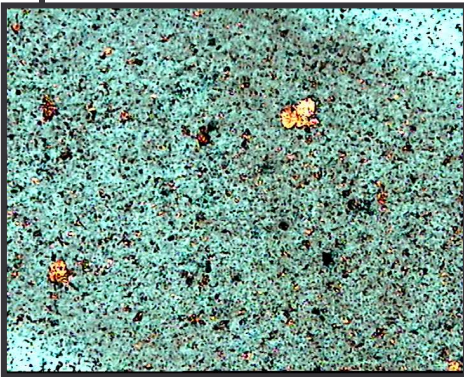
One mil. of the sample oil has been forced through a 13-mm diameter **0.3-micron membrane filter @ 150 P.S.I.** The membrane filter has caught any contaminates present, filters are glass slide mounted for examination. This image represents a 1-mm diameter circle focused on the top layer of the filter **@ 100X**. The green/blue coloured background is the microscopes bottom light shining up through the glass slide illustrating density level of dirt, metal chunks and debris particles.

This image demonstrates the average debris level for sample No. 6050
*To achieve an acceptable life from this application,
this image should be clear, no particles*

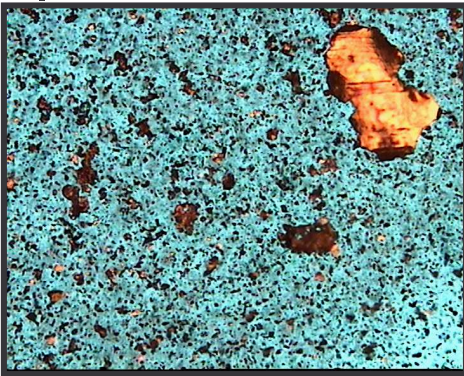
**Overview density of dirt,
Wear Metal Chunks and debris particles @ 200X.**

This sample is contaminated with 2 Body Fatigue Wear, Scuffing, Scuffing Wear – “Damaged Surface”, 3 Body Fatigue Wear.

Scuffing Wear – “Damaged Surface” Particles began when a primary wear mode was generated and not addressed, 2 Body Fatigue chunks occur when the machines cyclic application of the stress, is in excess of the design value, together these wear modes are being forced through the load zone by the lubricant flow causing further damage by generating 3 Body Fatigue wear and finally rolled out flat to form Laminar Wear Metal particles. Friction Polymers are formed when the lubricant is heavily stressed.

Mainlube recommends that the gearbox flushed with Mainlube 245 Flush to assist with the debris removal. If after flushing there is a possibility that wear debris still remains, then repeat the process until they are both clean. The source of any Silica contamination should be established and prevented from recurring with a Mainlube Bladder Vent and Water Drain System.

Replace the lubricant with Mainlube 154 Synthetic Solid Boundary E P Gear Oil SAE 75w90, run for 10 minutes and take sample for benchmark.

Retest every 5000 klms until trends are established.

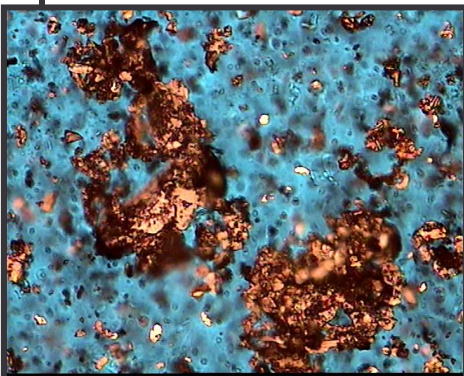
**Overview density of dirt,
Wear Metal Chunks and debris particles @ 500X.**
